Navajo Abandoned Uranium Mine

Site Screen Report

Nakai Chee Begay AUM Site

March 2010

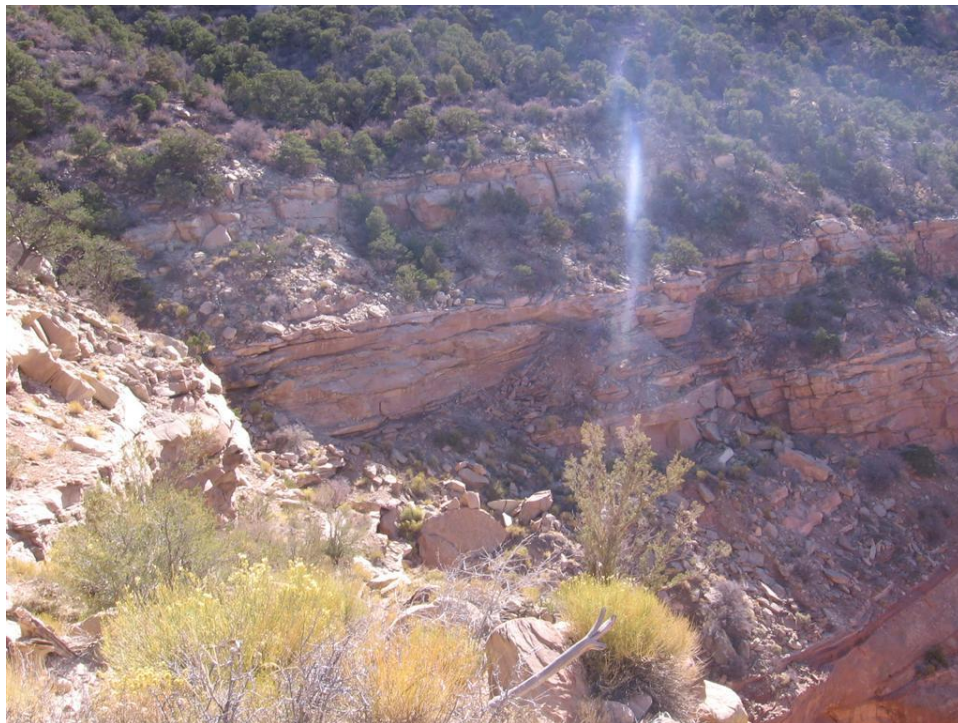
Waste debris extending southwest from adit 200 ft down cliff, approximately 50 ft wide, inaccessible, total estimated volume of 463 yd³

Photo 1. Waste debris down slope

Sealed adit; unreclaimed waste rock

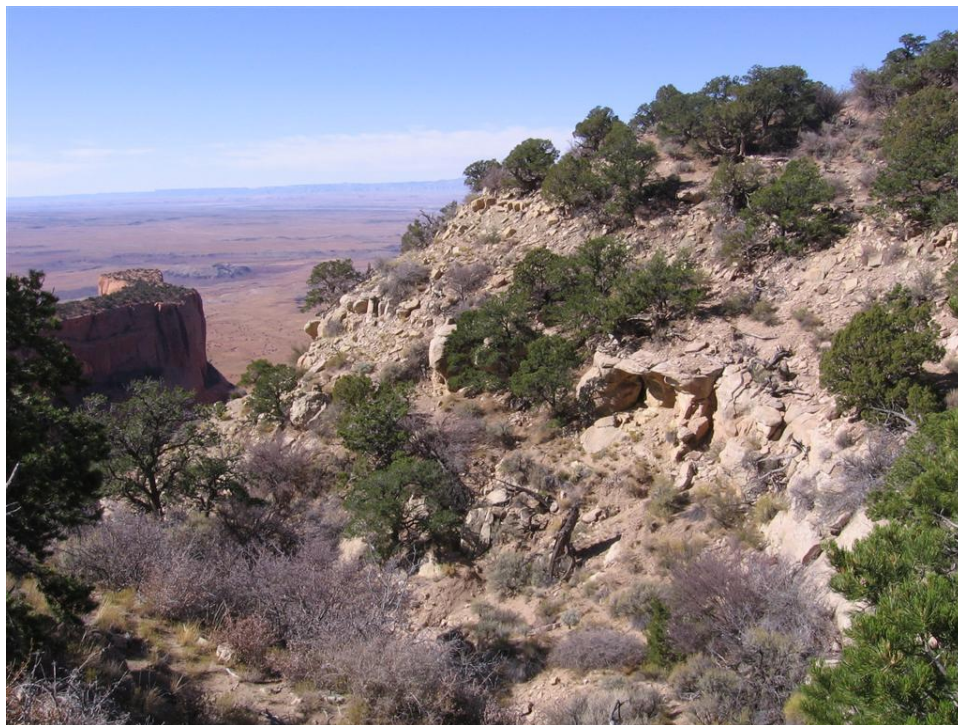
A total of 904 gamma radiation measurements were collected from the mine site, ranging from 8,696 cpm to 19,534 cpm. The majority of the site, including the adit and waste debris, were inaccessible. Measurements in the vicinity of the cliff face were found at levels up to 14,000 cpm. The measurements are represented in Figures 1 and 2.

Photo 2. Inaccessible portion of mine site

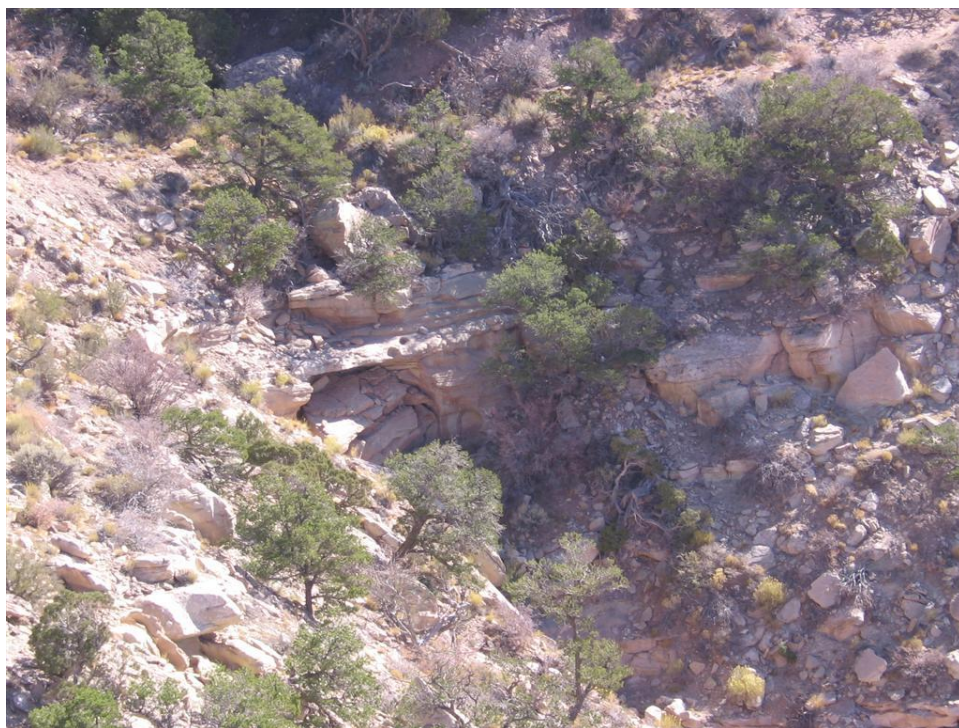
Inaccessible adit, roughly 6' x 6', appeared to be sealed with stone

Photo 3. Stone sealed adit

Is there a reclamation cap or sealed adit in place at the site? Yes

Is the cap/seal functionally intact? Yes
